Late Non-Anastomotic Rupture of a Bifurcated Dacron Aortic Graft Treated Using a Gore Excluder Limb Endoprosthesis

Division of Vascular and Endovascular Surgery, Ospedale San Giovanni Bosco, Turin, Italy

Key Words: Non-anastomotic rupture, Dacron graft, Endoprosthesis, Gore excluder

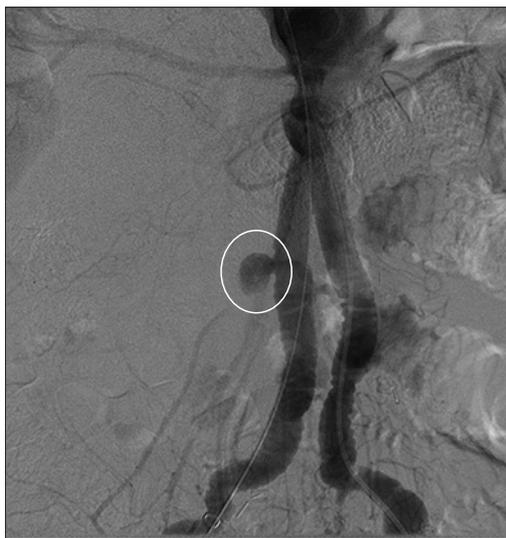
Fig. 2. Intraoperative digital subtraction arteriography showed the mid-graft source of bleeding (circle).

angiogram showed localization of the active bleeding in the mid-graft region of the right iliac branch (Fig. 2). Due to the lack of a suitably large stent-graft in our stockroom and due to the urgency of the case, we decided to use an iliac limb of an abdominal aortic endoprosthesis to seal the breach. A 12 Fr Gore DrySeal introducer sheath (W. L. Gore & Associates Inc., Flagstaff, AZ, USA) was placed through the right femoral access to accommodate a 14.5 mmx10 cm limb endoprosthesis (Gore Excluder[®] PXC141000; W. L. Gore & Associates Inc.). It was advanced over an Amplatz Super Stiff 0.035-inch guide wire (Boston Scientific, Marlborough, MA, USA) in the defective prosthetic branch and then deployed. Final angiogram confirmed the complete exclusion of the bleeding stump with patency of the prosthetic limb (Fig. 3). Subsequently, an 8 Fr Angio-Seal device (Terumo Medical Corporation, Somerset, NJ, USA) was used to seal

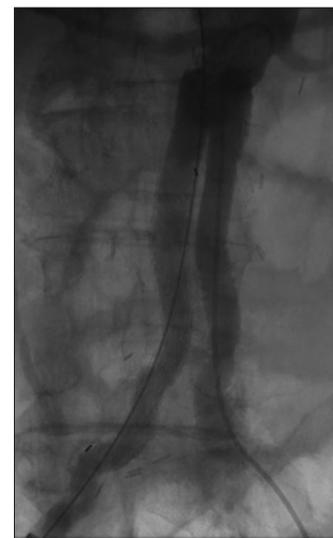
Fig. 3. Angiography after the excluder limb deployment demonstrated adequate relining of the defective prosthetic branch with no detectable bleeding.
